# Manhole Inspection Summary

Manhole # S53AA\_016MH

Insp Date: **3/4/08 9:41 AM**

**Location** Address: **Robinson**

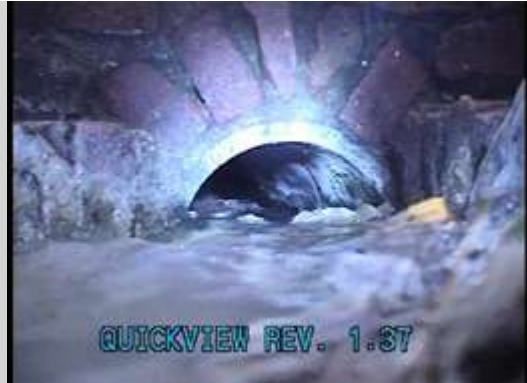
12 O'Clock Outflow

8 in. Circular Gravity Sewer  
Pipe Out @ 12 O'Clock

Pipe Height: **8.4** (in.) Rod and Bar (Angled)  
Pipe Material: **Clay** ☐ Pipe Lined  
Invert Depth: **9.35** (ft.) Flow Characteristics: **Fast**  
Deposits: ☐ None ☐ Mud ☒ Sludge ☒ Debris ☐ Grease  
Silt Depth: **1** (in.) Deposits Extent: **Light**  
Infiltration: **None** Pipe Seal Cond: **Sound**

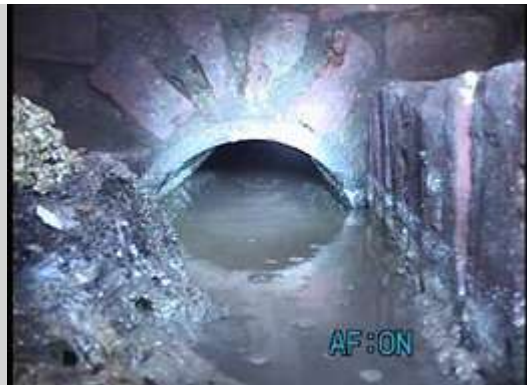
6 O'Clock Inflow

8 in. Circular Gravity Sewer  
Pipe In @ 6 O'Clock

Pipe Height: **8.4** (in.) Rod and Bar (Angled)  
Pipe Material: **Clay** ☐ Pipe Lined  
Invert Depth: **9.30** (ft.) Flow Characteristics: **None**  
Deposits: ☒ None ☐ Mud ☐ Sludge ☐ Debris ☐ Grease  
Silt Depth: (in.) Deposits Extent:  
Infiltration: **None** Pipe Seal Cond: **Sound**

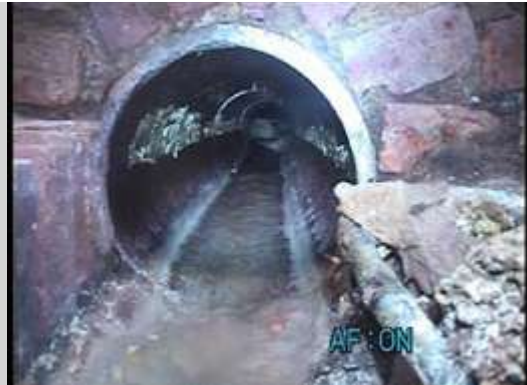
9 O'Clock Inflow

8 in. Circular Gravity Sewer

Pipe In @ 9 O'Clock

Invert Depth: **8.90** (ft.) Flow Characteristics: **Fast**

Deposits: ☒ None ☐ Mud ☐ Sludge ☐ Debris ☐ Grease

Infiltration: **None** Pipe Seal Cond: **Sound**
